Technical Series

01-104

## MONITORING THE PERFORMANCE OF AN EIFS RETROFIT ON A 15-STOREY APARTMENT BUILDING

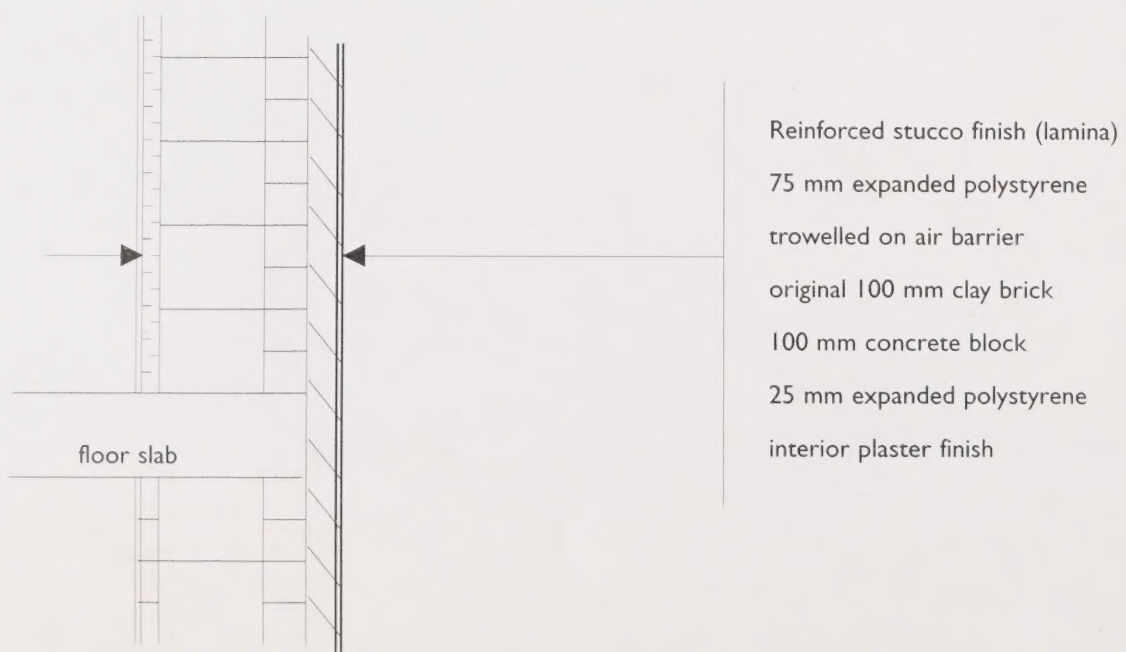
**Figure 1: Section of Retrofitted Wall Assembly**

The new EIFS over-cladding system consists of an acrylic stucco lamina (base coat, reinforcing mesh and finish coat) installed over 75 mm expanded polystyrene insulation. As a fully adhered system, the insulation is applied directly to the brick masonry (substrate) using

a two-coat trowel-applied proprietary Dryvit material; the first coat prepares the surface while the second coat adheres the insulation to the prepared surface. The coating is intended to operate as the air barrier and drainage plane and may also function as the vapour barrier. The lamina and insulation act as the first line of defense against precipitation. The second line of defense is the flashed drainage plane located at the substrate. Vertical channels located in the interior face of the insulation are intended to drain rainwater that penetrates to the coating (see Figure 1). The channels are flashed to the exterior every five stories and also laterally within the cavity above window heads. Intersections of the trowelled-on air barrier and other elements are sealed with self-adhering, rubber-modified bitumen sheet membrane, tape and/or sealant. Further, spray urethane foam is installed between the window frame and the rough opening.
